Tin Whisker Observations
on Tin-Coated Copper Bus Bar
Obtained from
“A Large Paper Mill in Sweden”

Jay Brusse/Dell Perot Systems at
NASA Goddard Space Flight Center
December 2009
Jay.A.Brusse@nasa.gov

Images from 2009 Arcing Event @ Paper Mill in Sweden

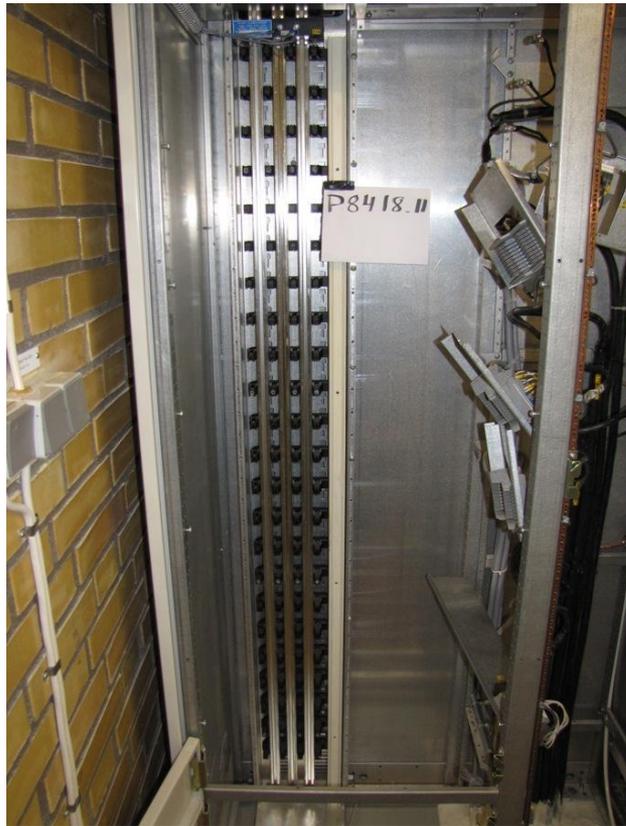
Cabinet stripped from feeder groups. Vertical bus bars visible

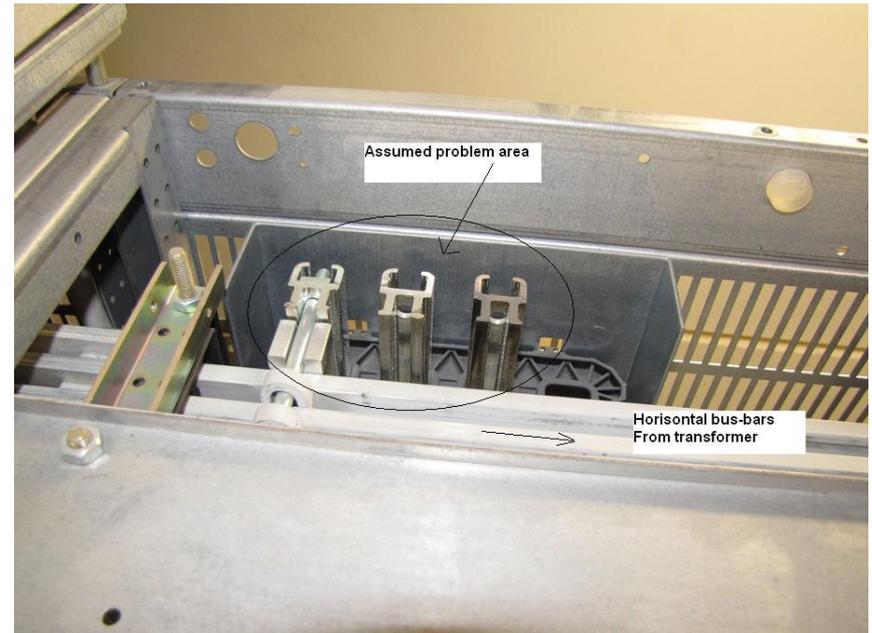
Top of cabinet removed. Top of vertical bus bars visible.

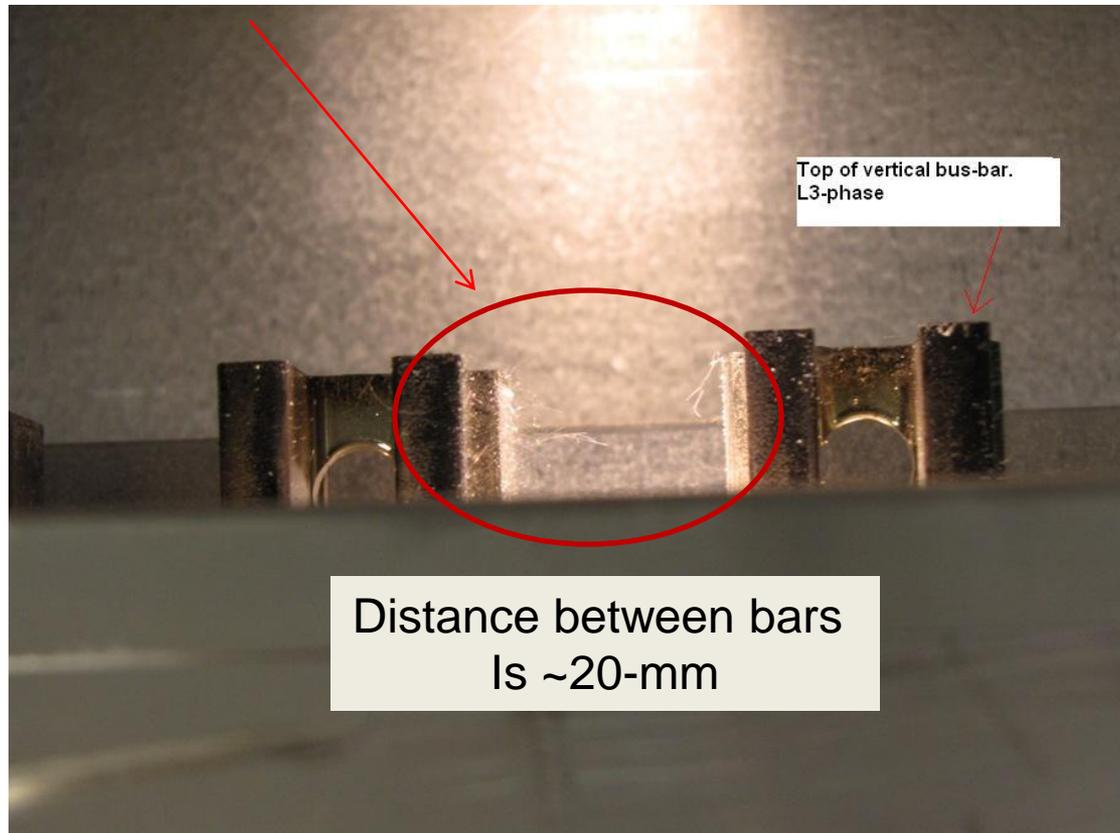
Top of vertical bus bars.

Suspicious filaments visible in gap between bars

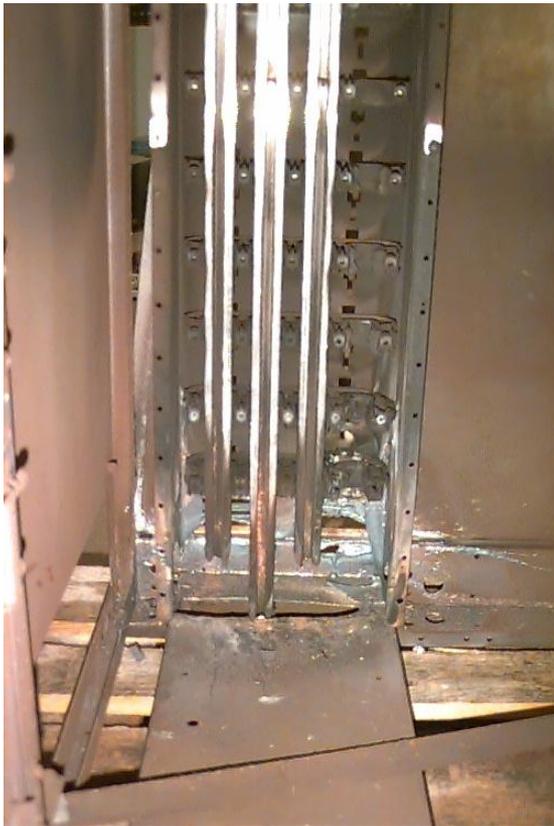
Cabinet Disassembled

After Arcing

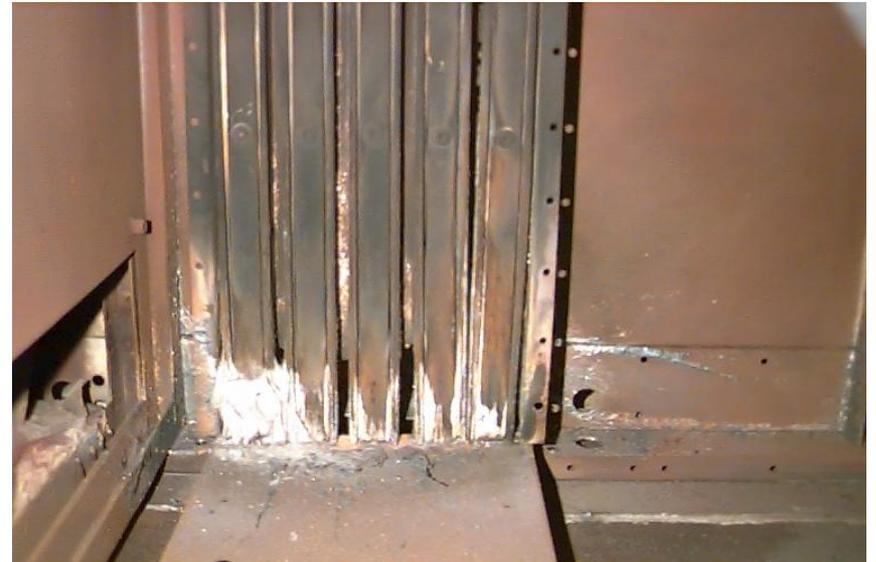
Arcing Damage

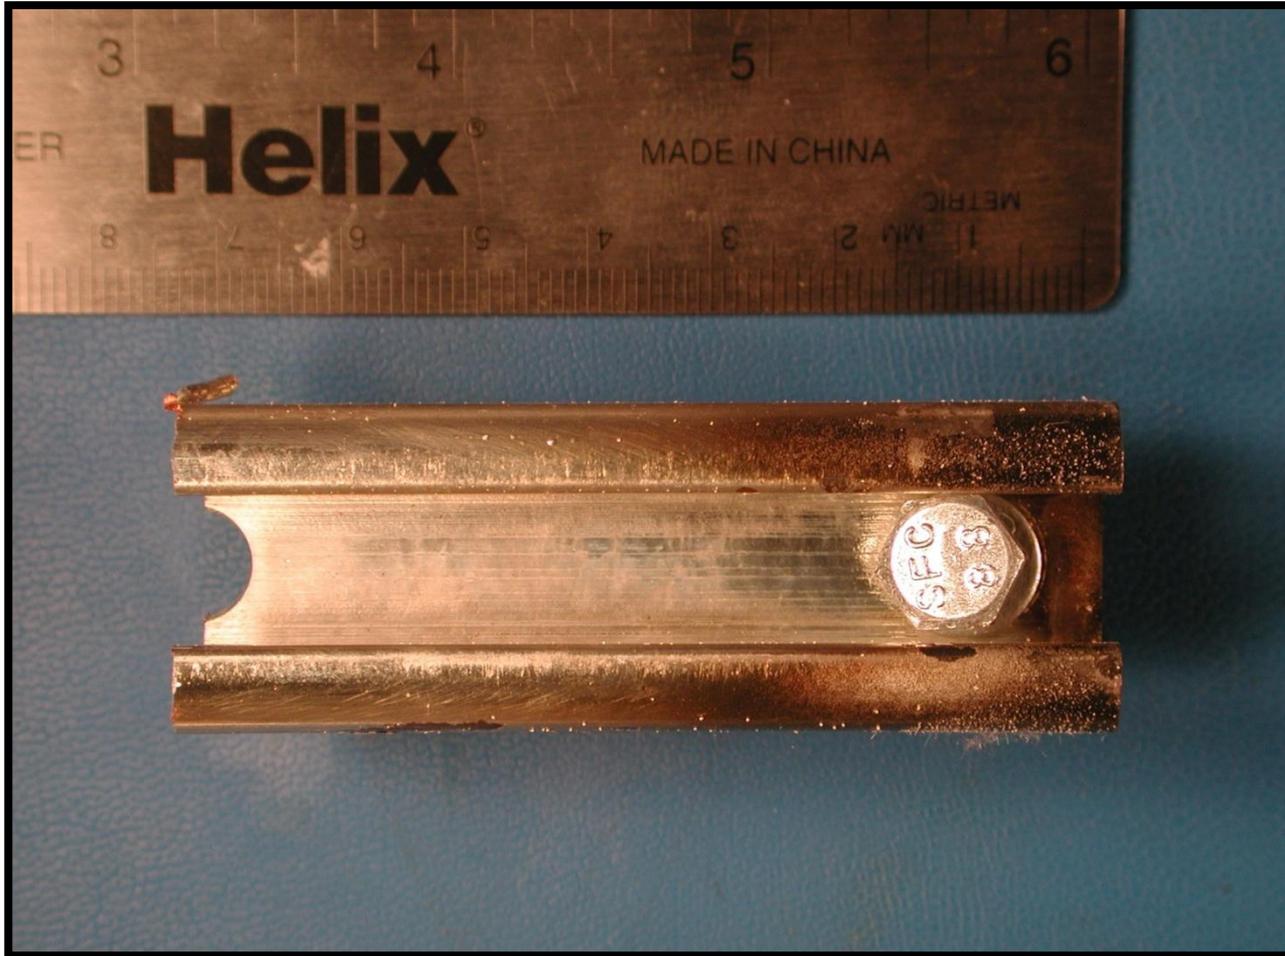
Bus Bar Sample Cut by Anders Johansson and Sent to NASA for Analysis Herein

- Bus bar base metal = Copper (Cu)
- Surface Finish = Tin (Sn)
- Surface Finish Thickness = variable along length of bus bar
 - Range from 1.26 - 26.2 microns in areas examined

- Thinner Sn coating is located at the uncut end of the bus bar (by XRF)
- **TIN WHISKERS:**
 - Extensive tin whisker formations were confirmed by these inspections

- Many whiskers are longer than 1-mm, some whiskers >3-mm.
 - Tin whisker density (# per area) is non-uniform
 - Very high density nearest the uncut ends of the bus bar (where plating is thinner)

- Very low density near the cut end of bus bar
- Localized darkening, blistering and flaking of the tin surface finish was observed
 - Most noticeable in region with highest tin whisker density.

- Discoloration looks like charring of the surface , but cause has not been determined
 - Might occur during localized heating of the bus bar (e.g., possible arcing event), but supplier does not believe sample provided for analysis had been involved in any arcing events

- EDS of this region shows only Sn and O (i.e., no C). May be very thick tin-oxide layer.

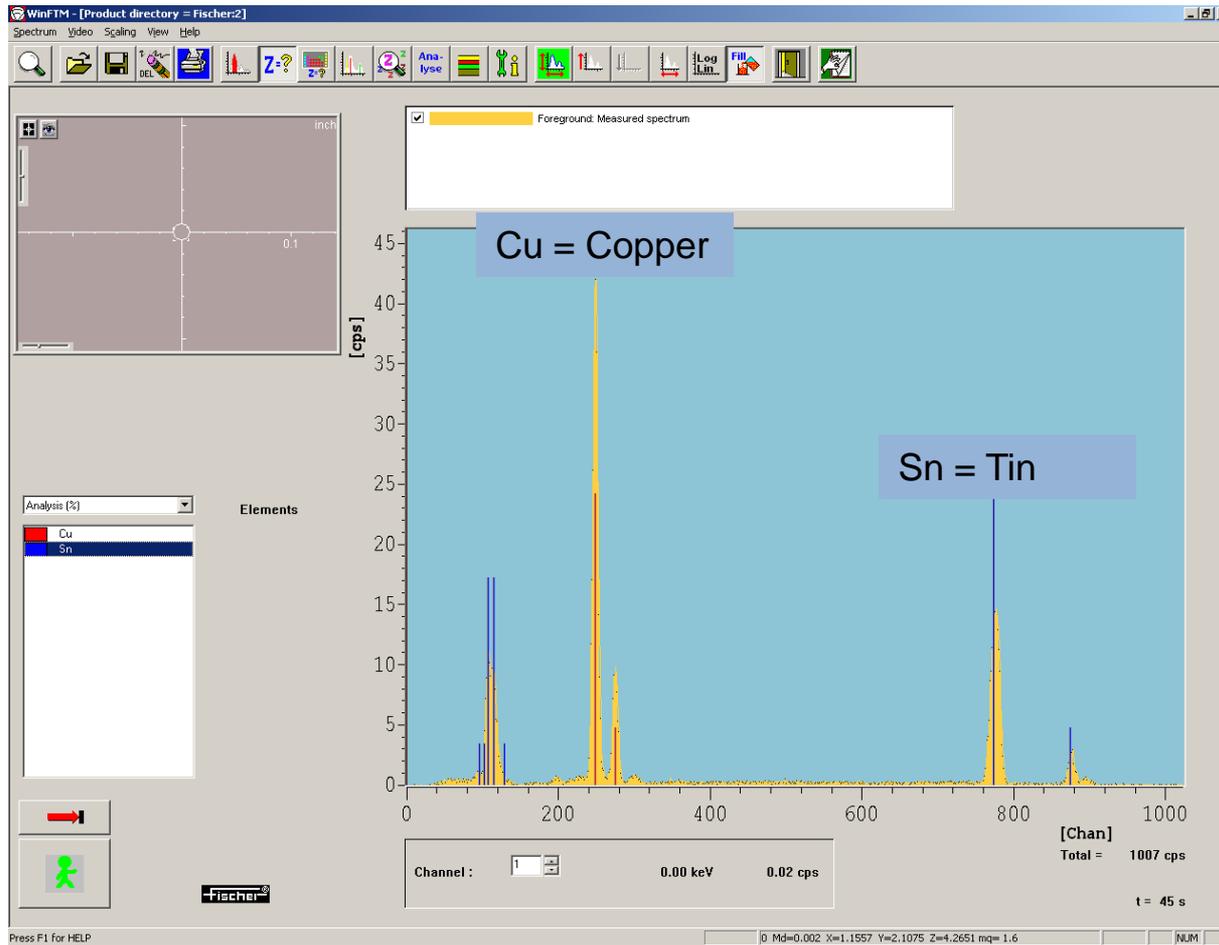
XRF Spectrum of Bus Bar Confirms Tin Over Copper Construction

XRF is a non-destructive method for measuring both the thickness and the elemental composition of thin surface finishes and the underlying base material.

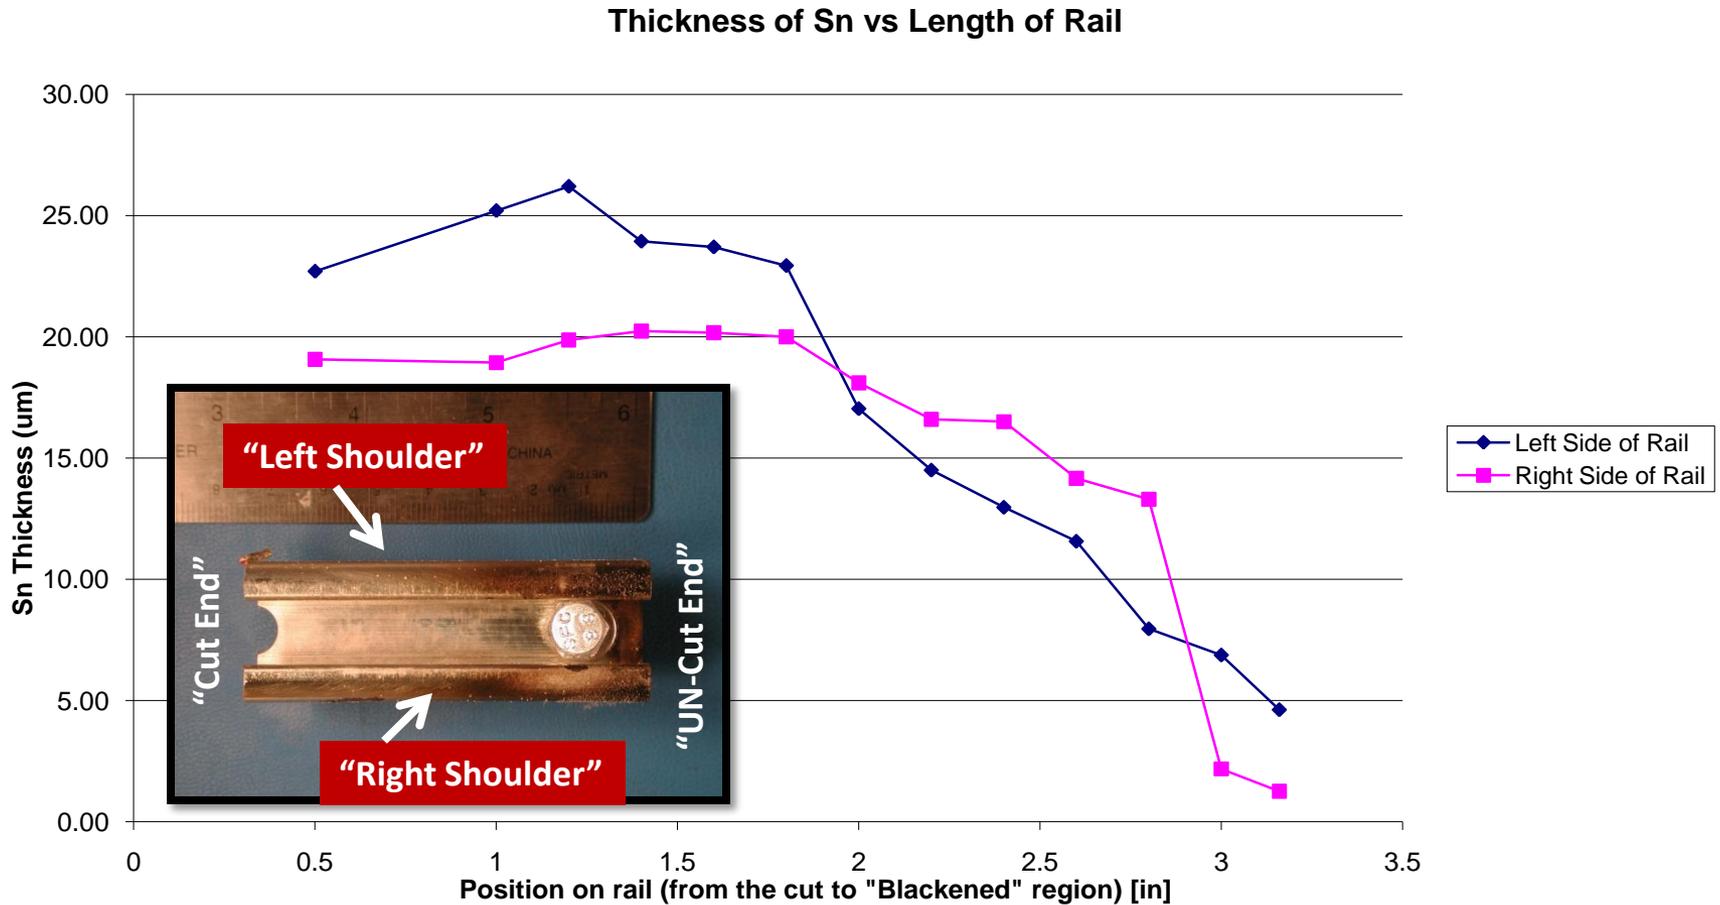
Tin thickness vs. Position on Shoulders of Rail

(Measured by X-Ray Fluorescence)

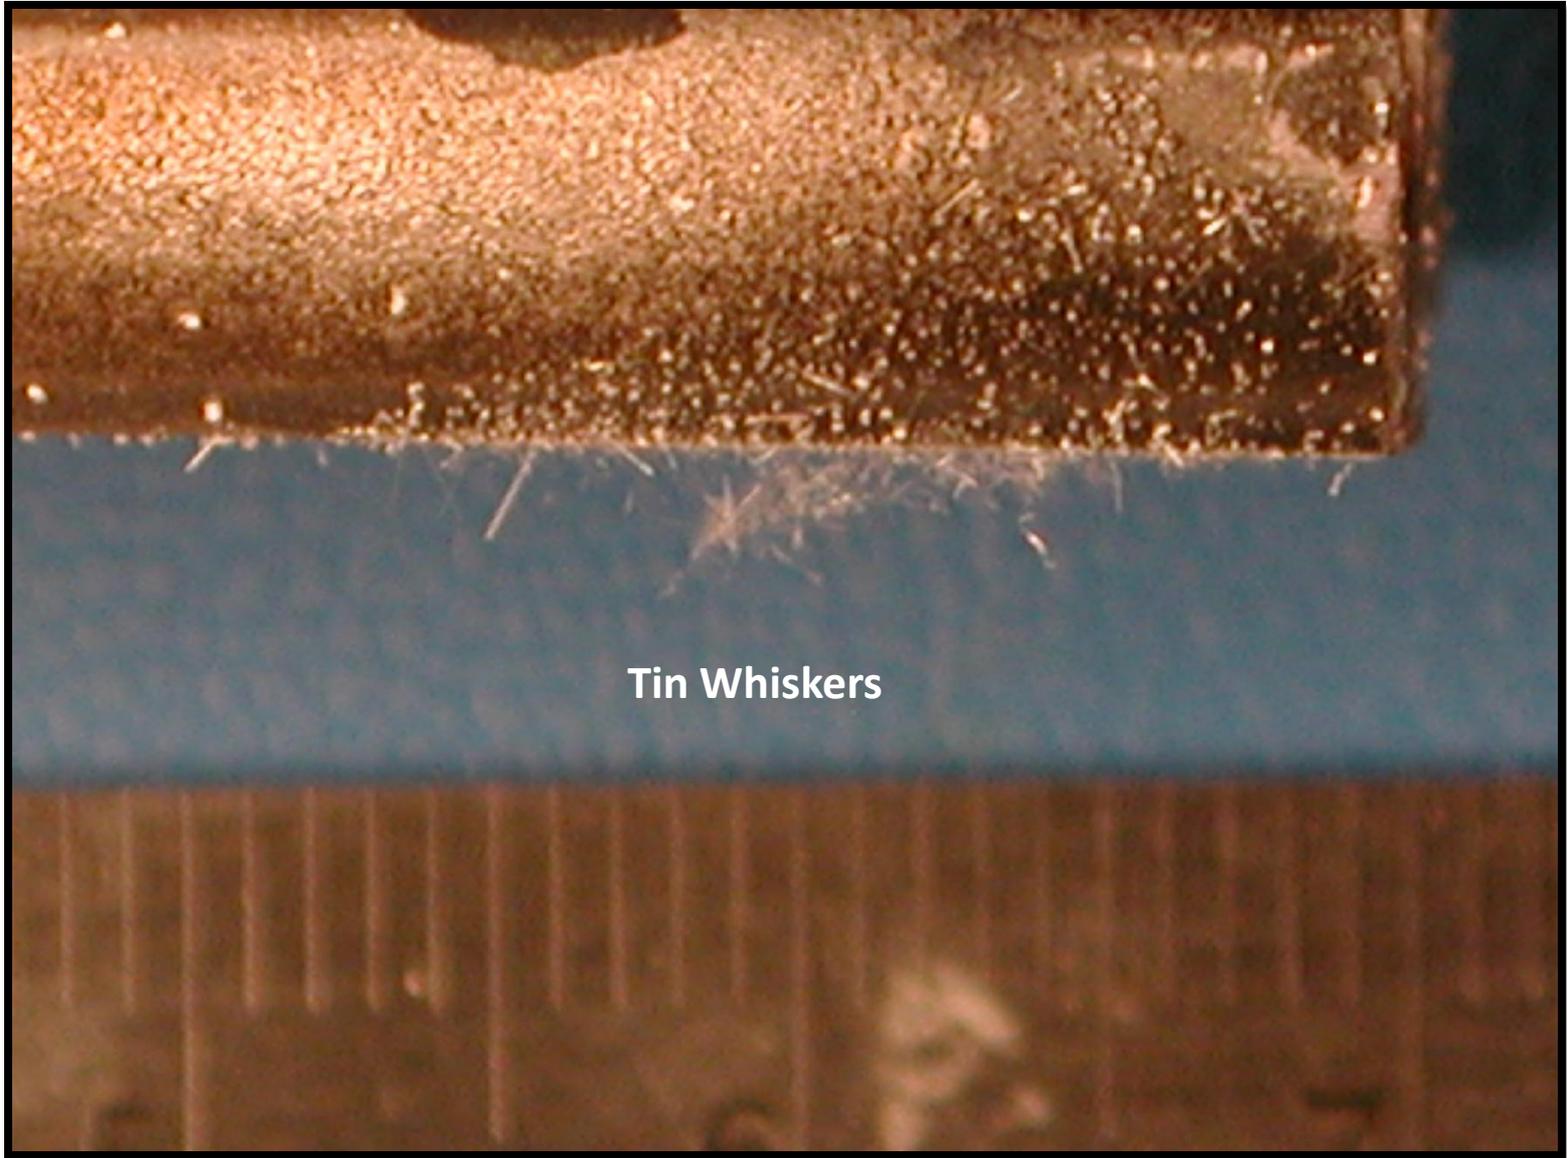
"Blackened" End of Bus Rail with High Density (#/area) of Tin Whiskers

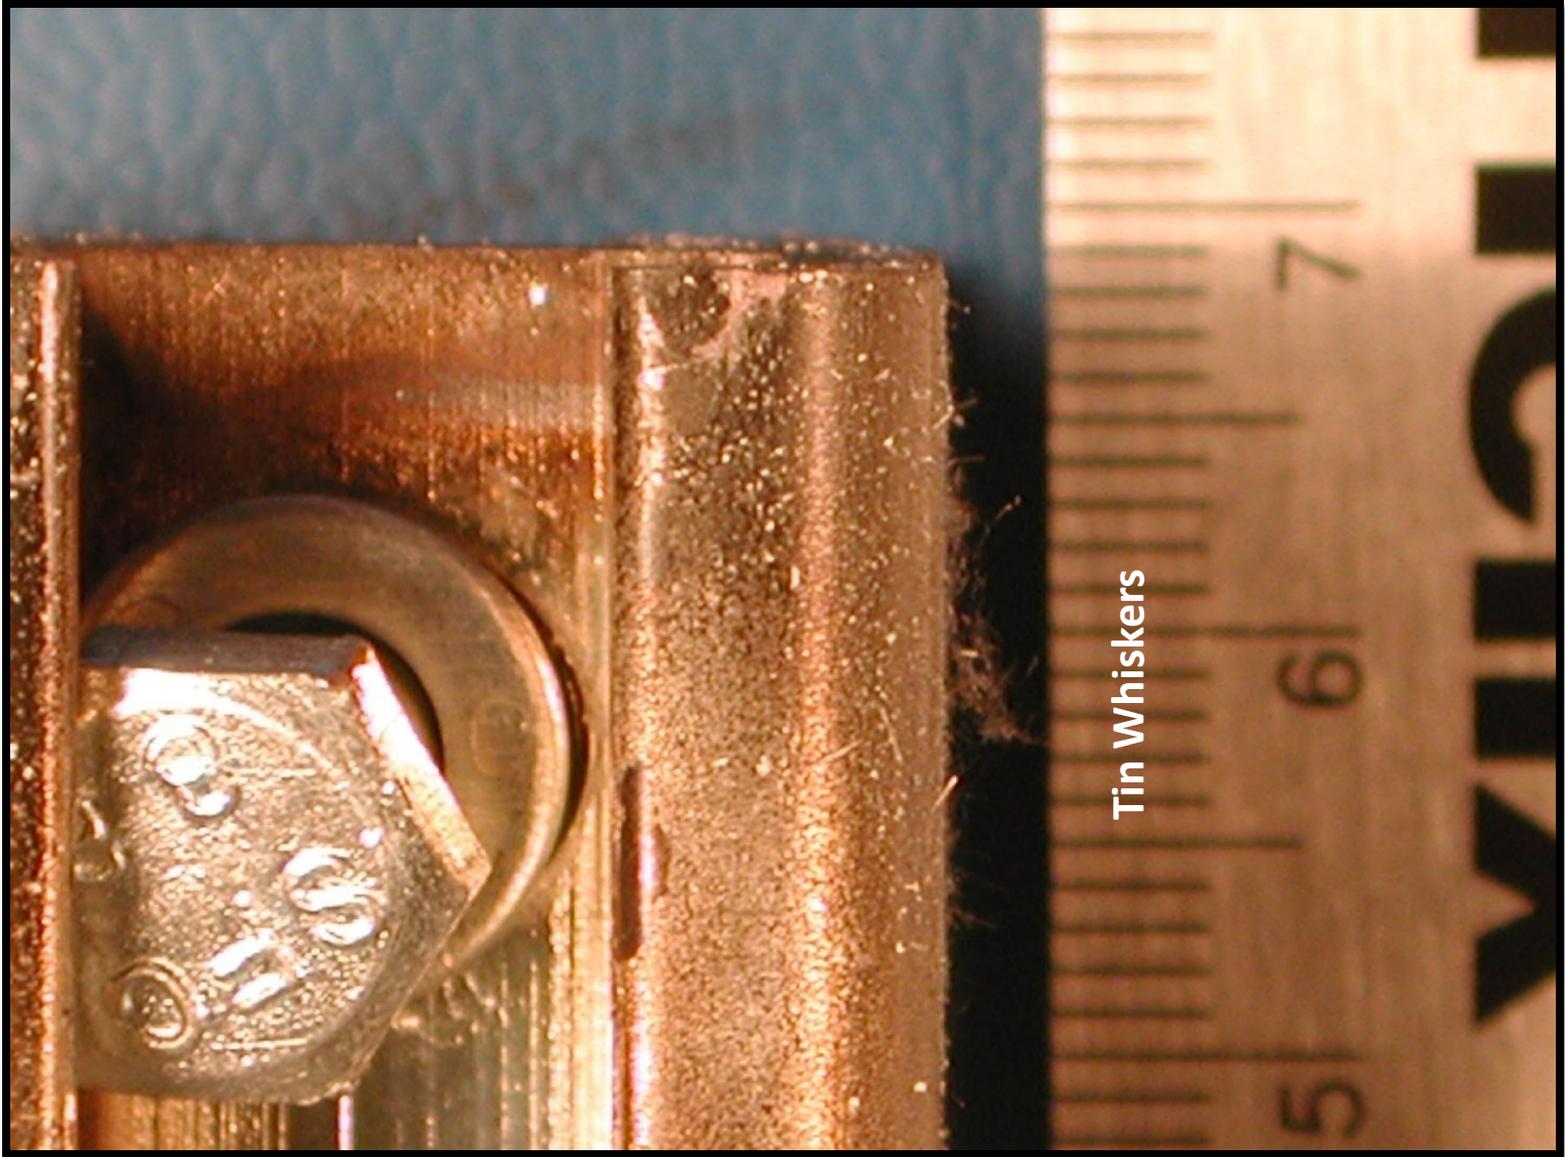
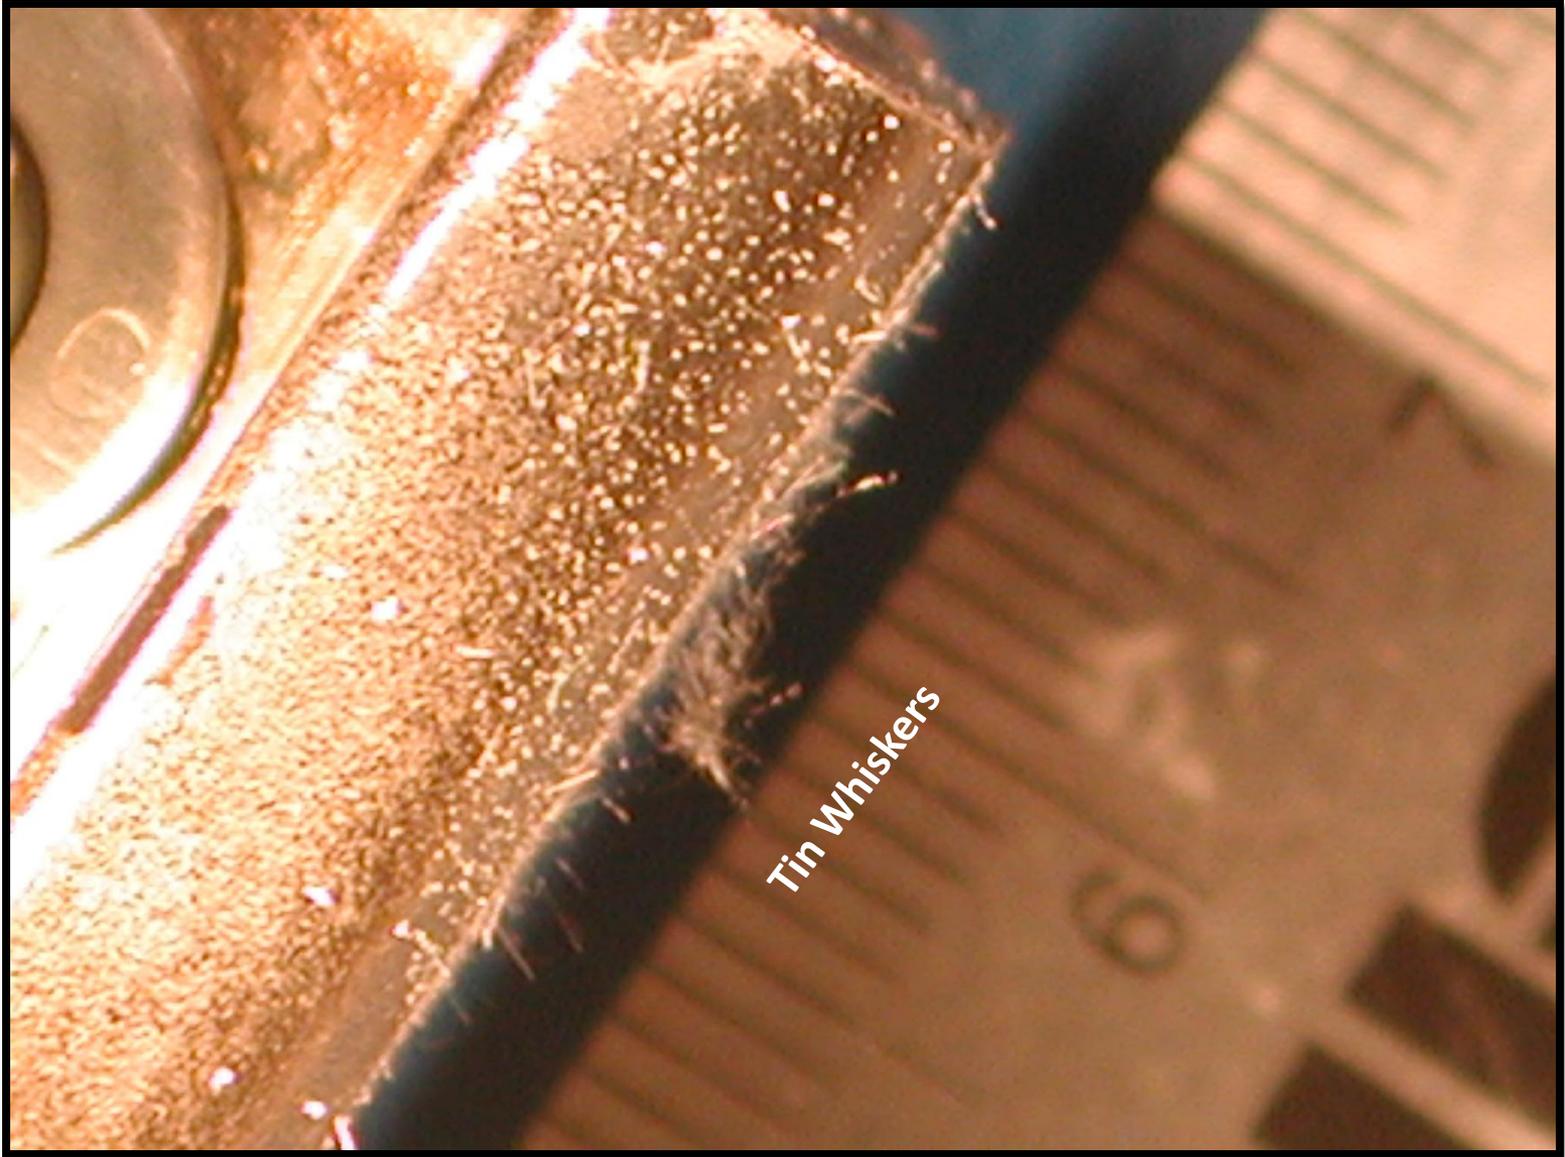
Tin Whiskers

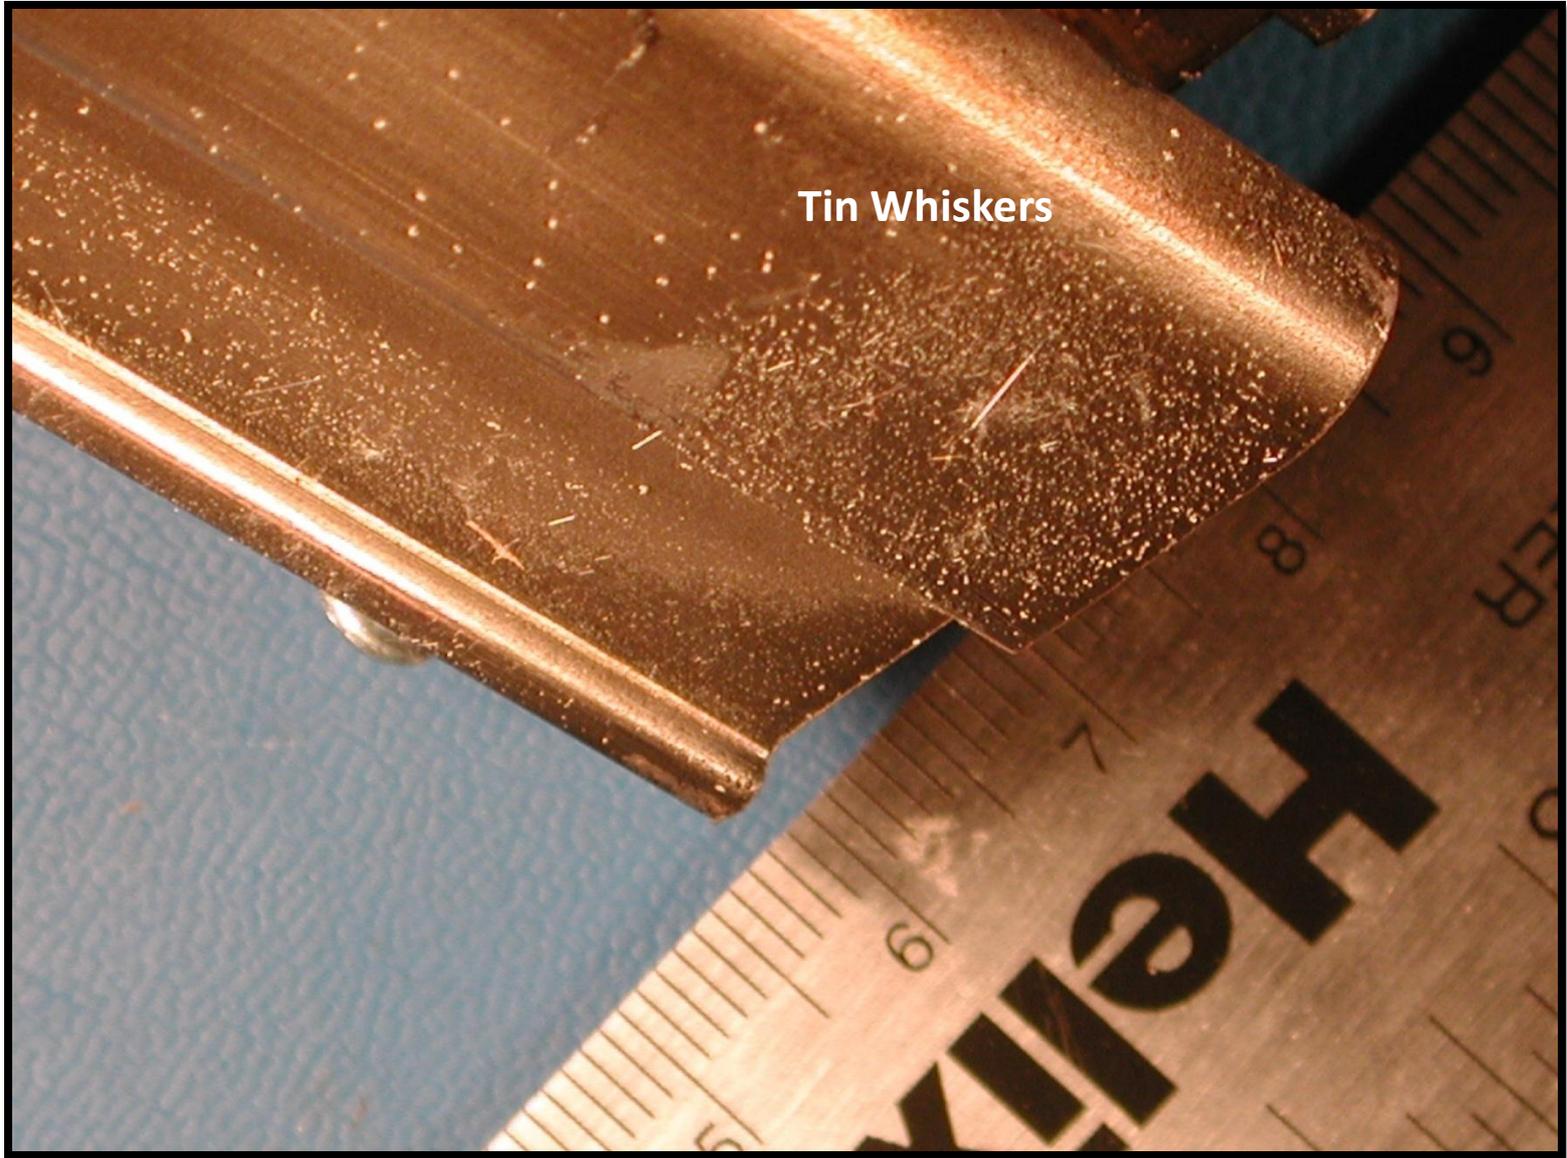
Tin Whiskers

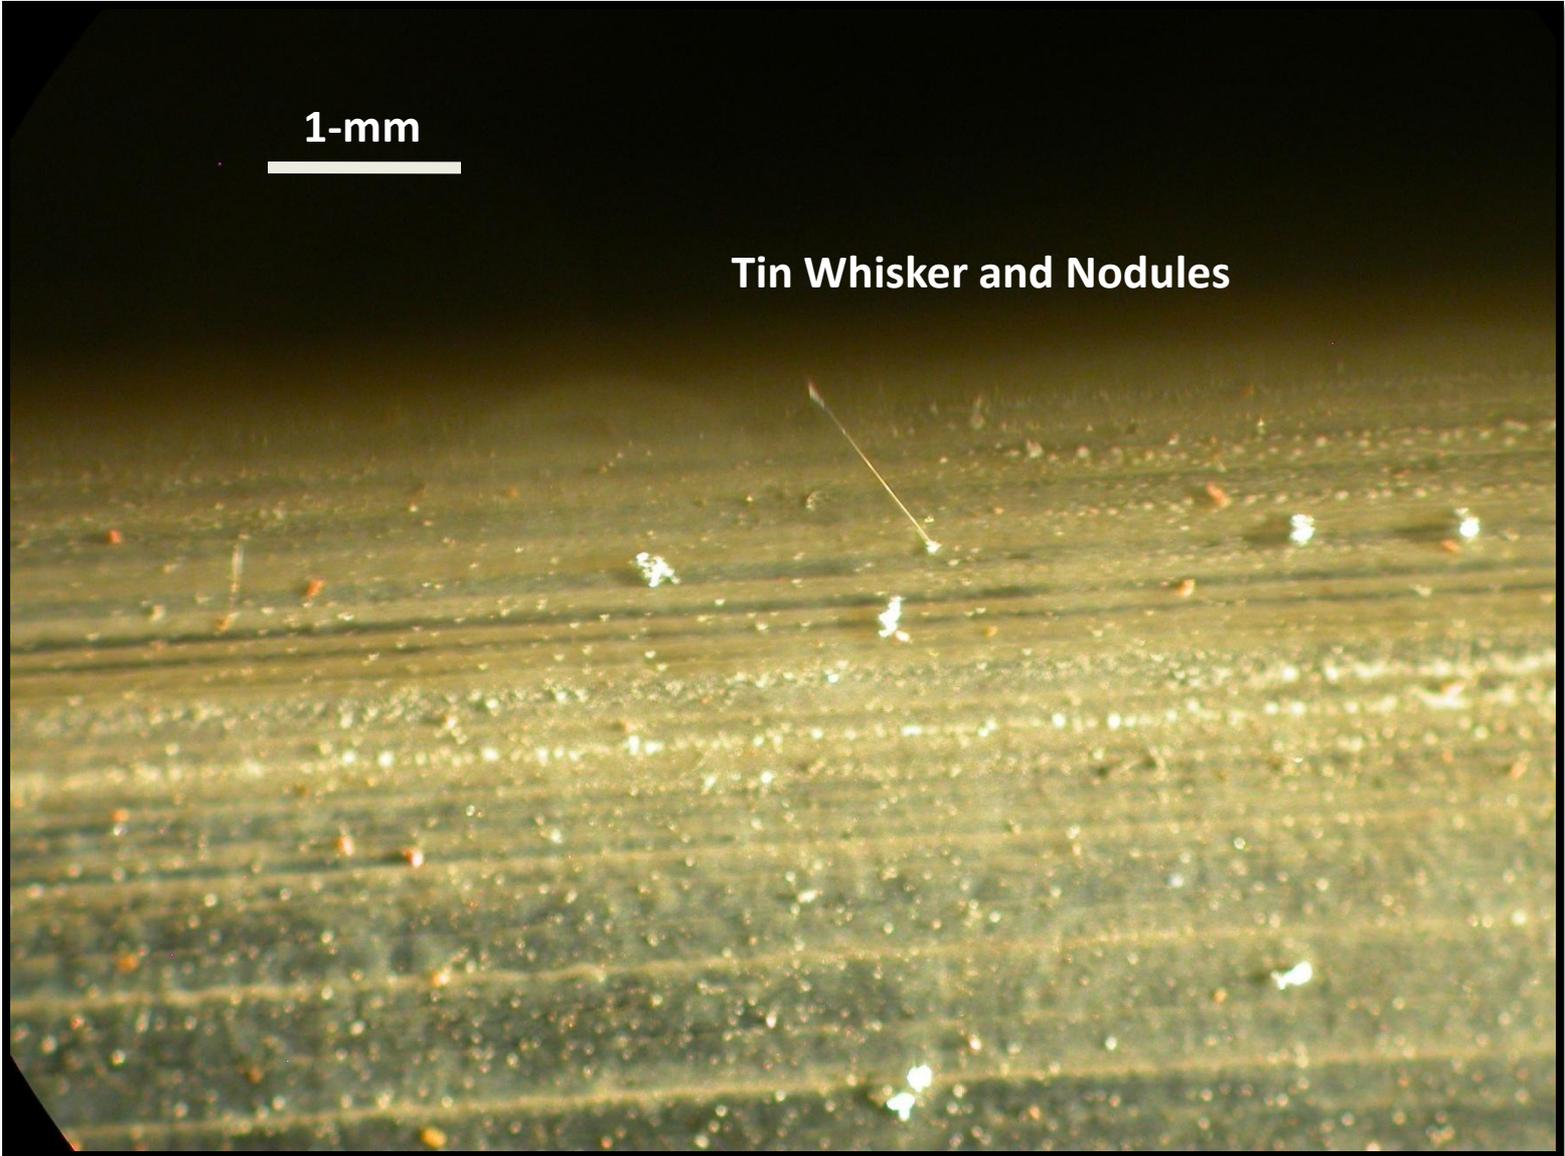
Tin Whisker and Nodules
